NOVEMBER TECH TIP

REAR ROTOR RUBBING ON BACKING PLATE AFTER INSTALLATION

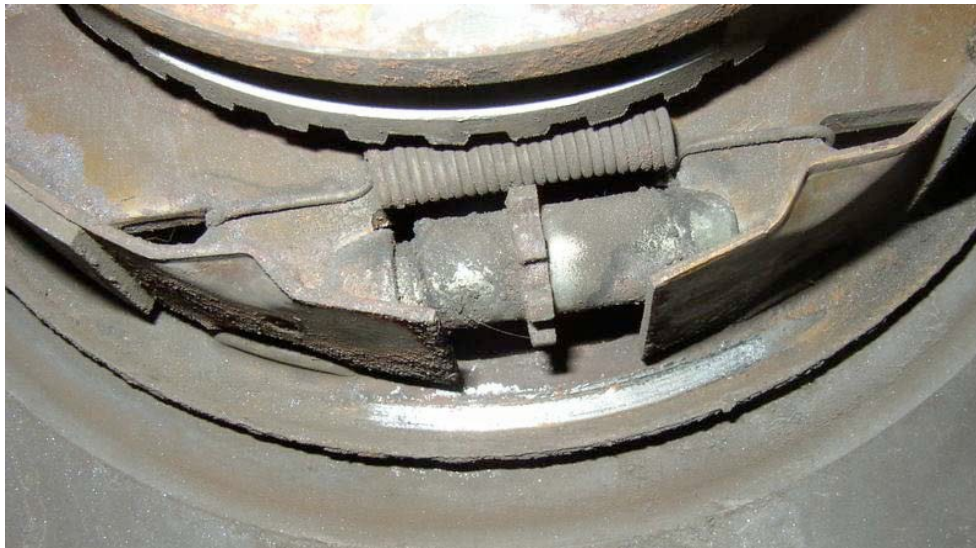
On some Subaru, Honda, and other vehicles utilizing a “Drum-in-Hat” type parking brake system operated in a corrosive environment (road de-icers, salt, etc) the new rear brake rotor may rub against the backing plate. This condition may be caused by corrosion between the backing plate and knuckle assembly that has “jacked” the backing plate away from the knuckle such that it makes contact with the brake rotor. While some may machine/grind the inboard-most edge of the parking brake drum, the correct course of action is to disassemble the parking brake, remove backing plate from knuckle, thoroughly clean all components (replace parts as necessary) and reassemble..
